**KENTUCKY TRANSPORTATION CENTER**

# Stockpiling Hydrated Lime-Soil Mixtures

June 2007

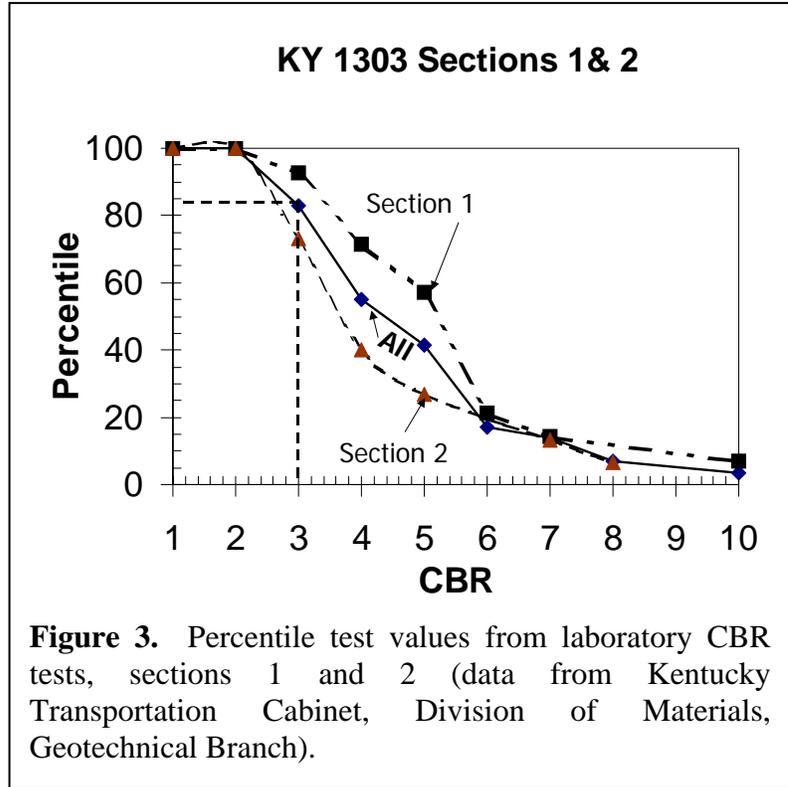
**Figure 3.** Percentile test values from laboratory CBR tests, sections 1 and 2 (data from Kentucky Transportation Cabinet, Division of Materials, Geotechnical Branch).

The percentile test value as a function of CBR laboratory tests is shown in Figure 3. At the 85<sup>th</sup> percentile test value the CBR value is 3.1 for Section 1, 2.6 for Section 2, and 2.8 for the two sections combined. Normally the 85<sup>th</sup> percentile test value is an acceptable selection for pavement design (Hopkins 1991). The use of chemical stabilization (hydrated lime) was fully justified in this case.

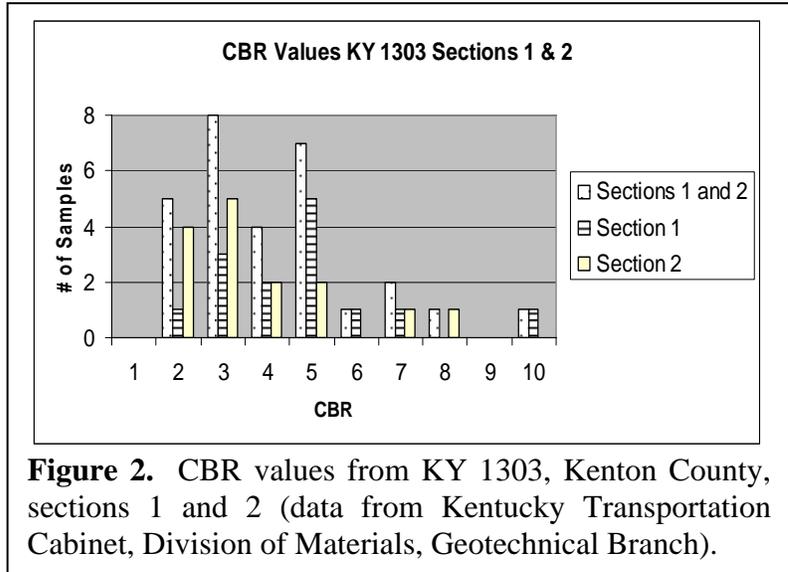
**Figure 2.** CBR values from KY 1303, Kenton County, sections 1 and 2 (data from Kentucky Transportation Cabinet, Division of Materials, Geotechnical Branch).

Thirteen of fourteen CBR samples that were tested had CBR values of 7 percent or less in Section 1. Thirteen of fifteen CBR samples had CBR values of 7 percent or less for Section 2. Past research (Hopkins, et al 1994) has recommended using chemical stabilization to improve CBR strength when the CBR value is less than about 7 percent. Results from laboratory CBR tests performed during the initial geotechnical investigation (Molen, 1998) are shown in Figure 2.

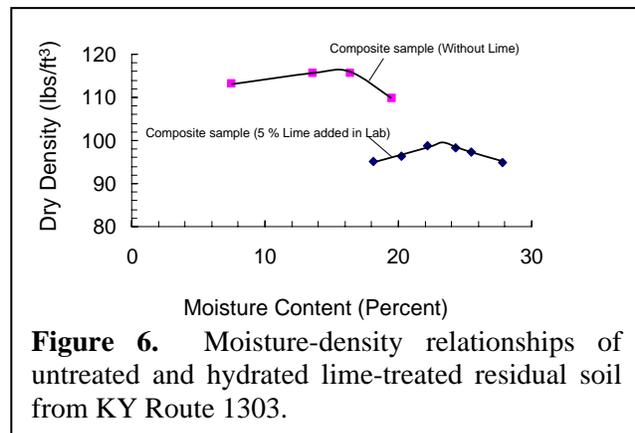
**Figure 6.** Moisture-density relationships of untreated and hydrated lime-treated residual soil from KY Route 1303.

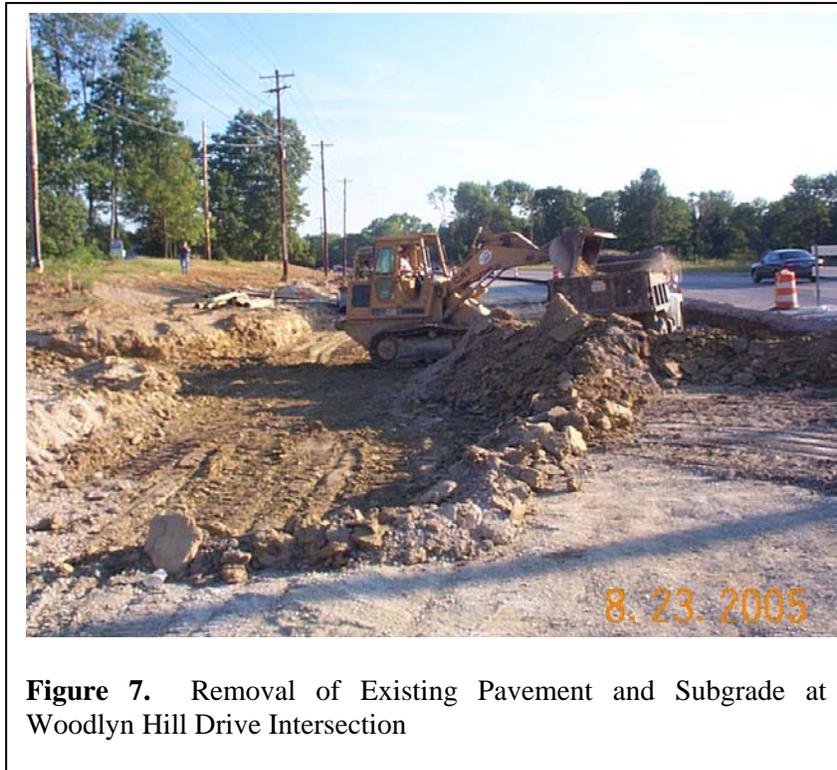
**Figure 7.** Removal of Existing Pavement and Subgrade at Woodlyn Hill Drive Intersection

Woodlyn Hill Drive was closed to traffic on August 22, 2005 and the intact pavement and aggregate base were removed to the desired elevation, as shown in Figure 7. Excavation was completed on August 23 and the lime-soil subgrade was constructed on the same day. Dense graded aggregate was placed on the subgrade the next day. Typically, a seven-day curing time is required for lime- subgrade stabilization. The stabilized subgrade was constructed by placing

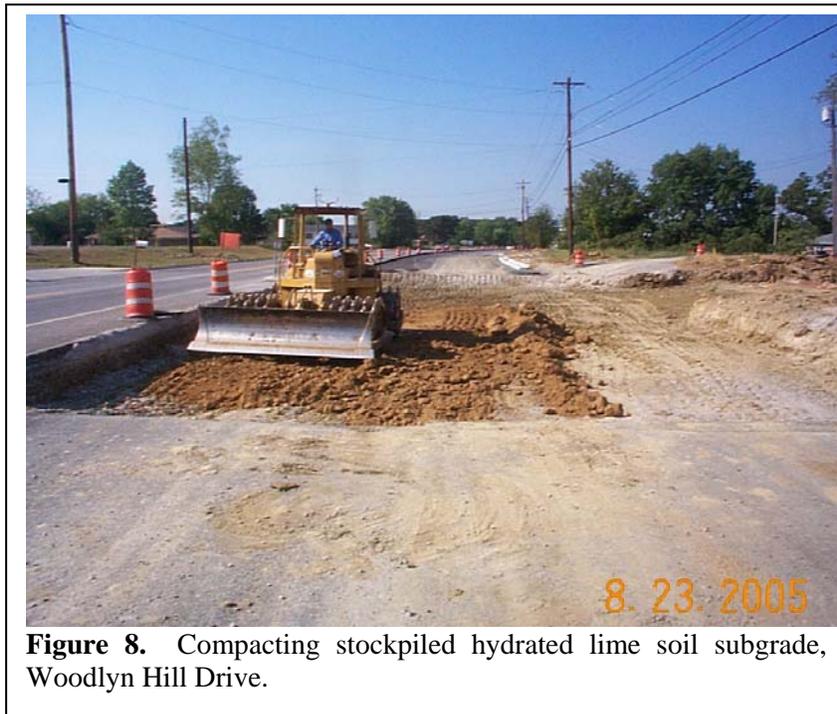
**Figure 8.** Compacting stockpiled hydrated lime soil subgrade, Woodlyn Hill Drive.

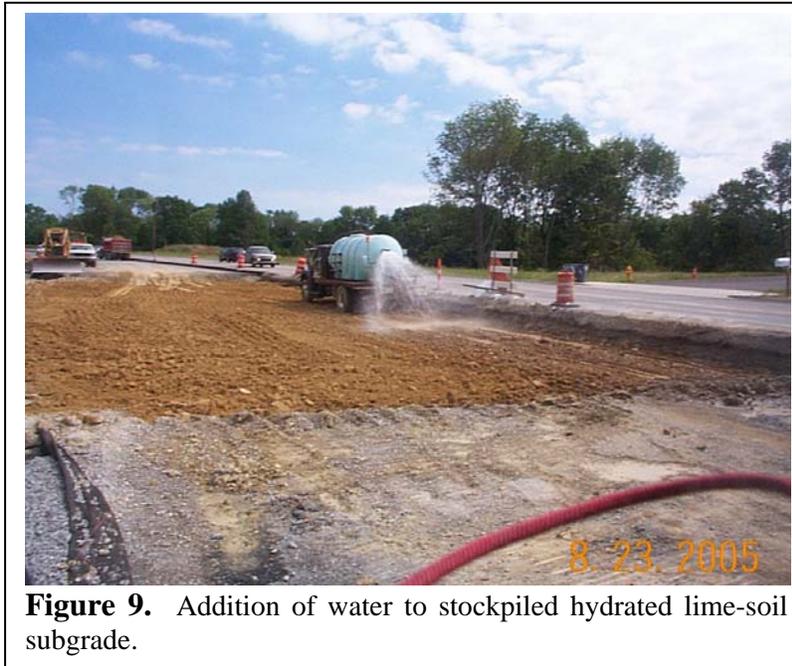
**Figure 9.** Addition of water to stockpiled hydrated lime-soil subgrade.

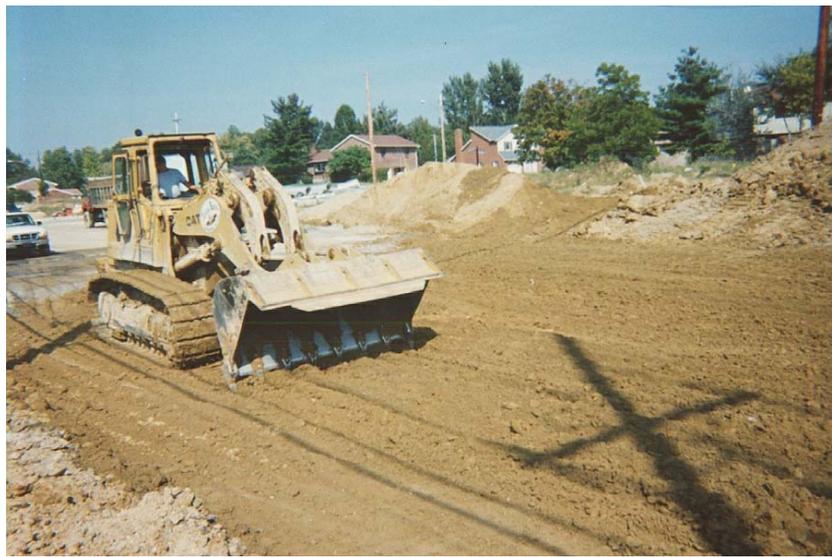
**Figure 10.** Mixing stockpile hydrated lime-soil with a front end-loader, Stevenson Road.

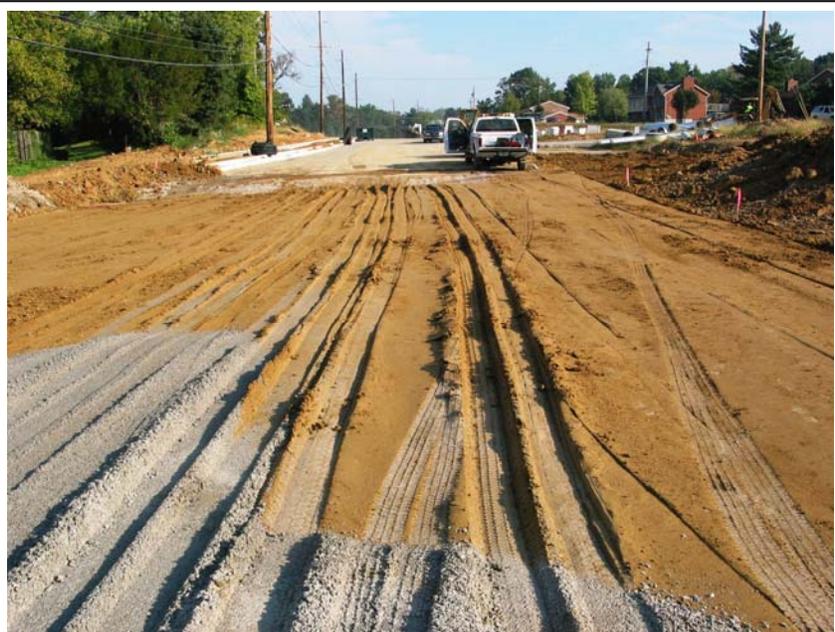
**Figure 11.** Subgrade rutting from construction traffic, Stevenson Road.

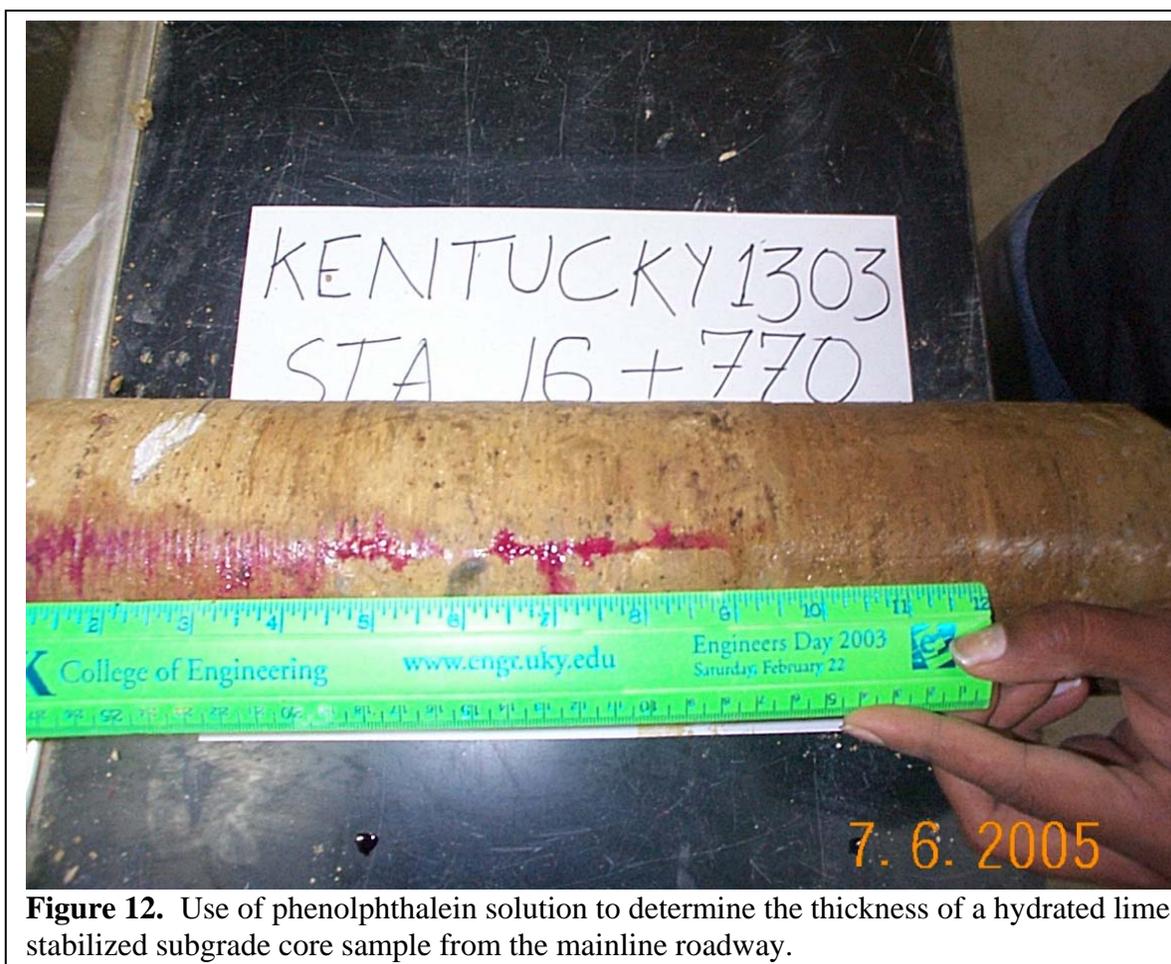
**Figure 12.** Use of phenolphthalein solution to determine the thickness of a hydrated lime stabilized subgrade core sample from the mainline roadway.

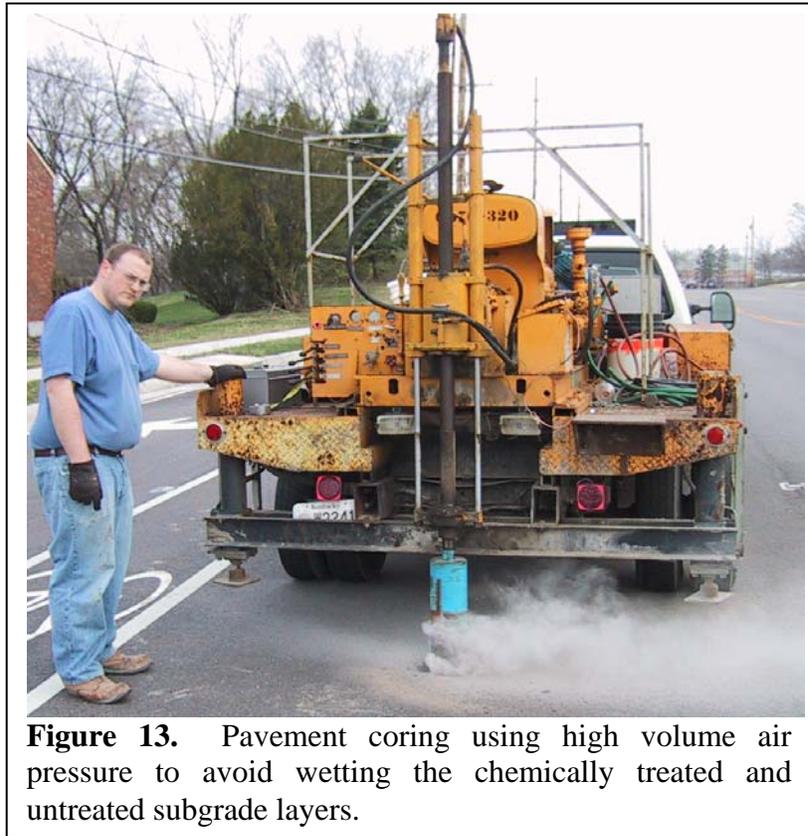
**Figure 13.** Pavement coring using high volume air pressure to avoid wetting the chemically treated and untreated subgrade layers.

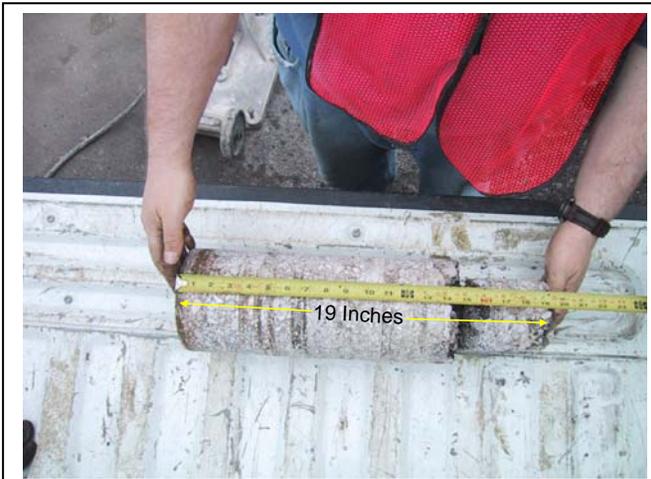
**Figure 14.** Measuring asphalt pavement thickness from a core.

Thicknesses of the asphalt layers asphalt cores of the pavement at each intersection were determined from measurements, as illustrated in Figure 14. Thickness of layer of hydrated lime stockpile material was determined using phenolphthalein. As illustrated in Figure 15, phenolphthalein reacts with hydrated lime and turns red. Cross sections of the pavement at the two intersections are shown in Figure 16. The pavement at the Stevenson intersection consists of 20 inches of asphalt, 5 inches of DGA, and 10 inches of hydrated lime-treated stockpile material. Dimensions of the Woodlyn intersection are essentially the same except the asphalt layer was about one inch less in thickness than the asphalt layer of the Stevenson Road intersection

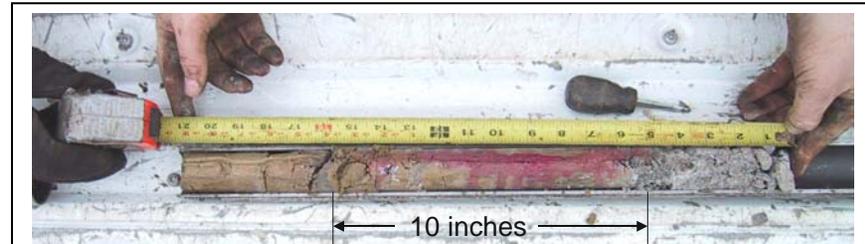
**Figure 15.** Determining thickness of hydrated lime treated subgrade using phenolphthalein solution at the Woodlyn intersection.

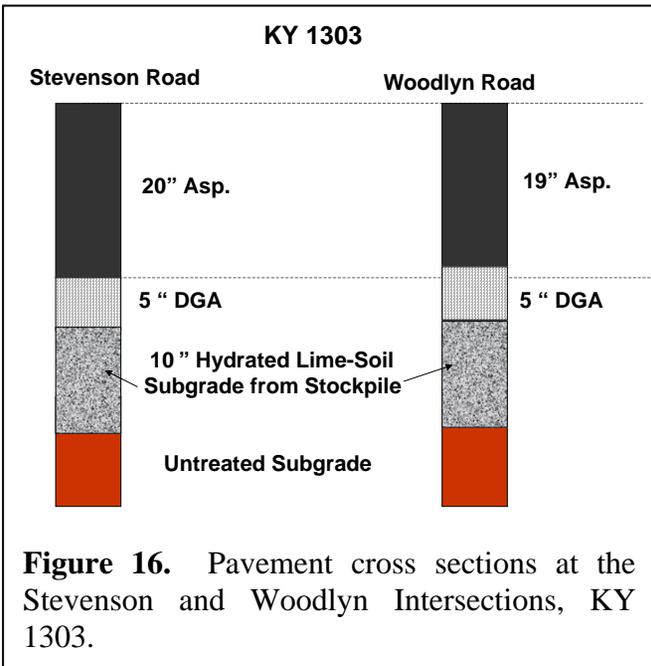
**Figure 16.** Pavement cross sections at the Stevenson and Woodlyn Intersections, KY 1303.

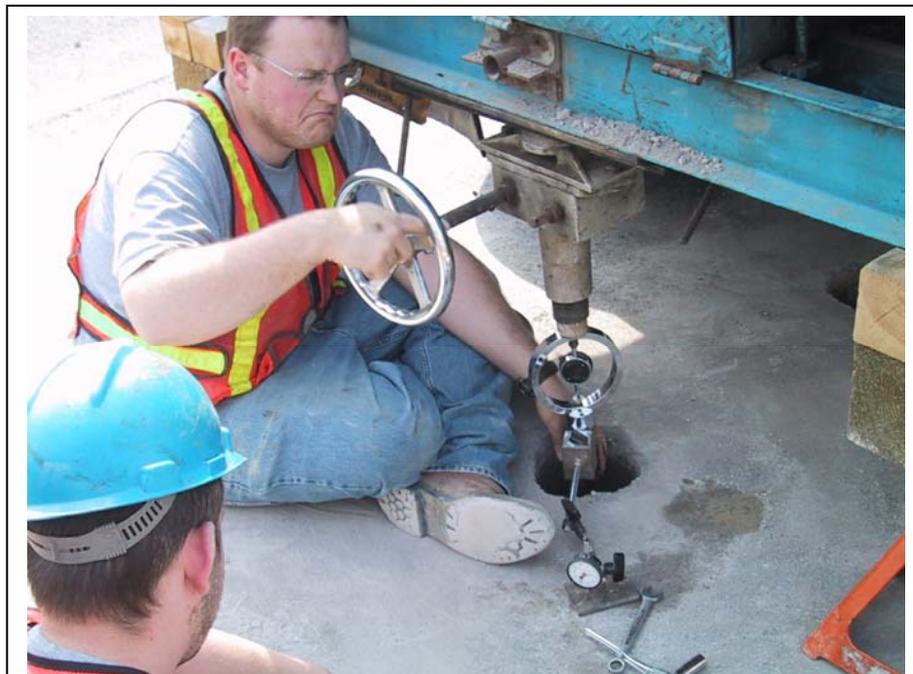
**Figure 17.** Performing in situ CBR test on top of the hydrated lime stockpile layer.

Two insitu CBR tests were performed on top of the treated subgrade at each intersection. A view of the performance of this test is shown in Figure 17. Minimum values of in situ CBR at the

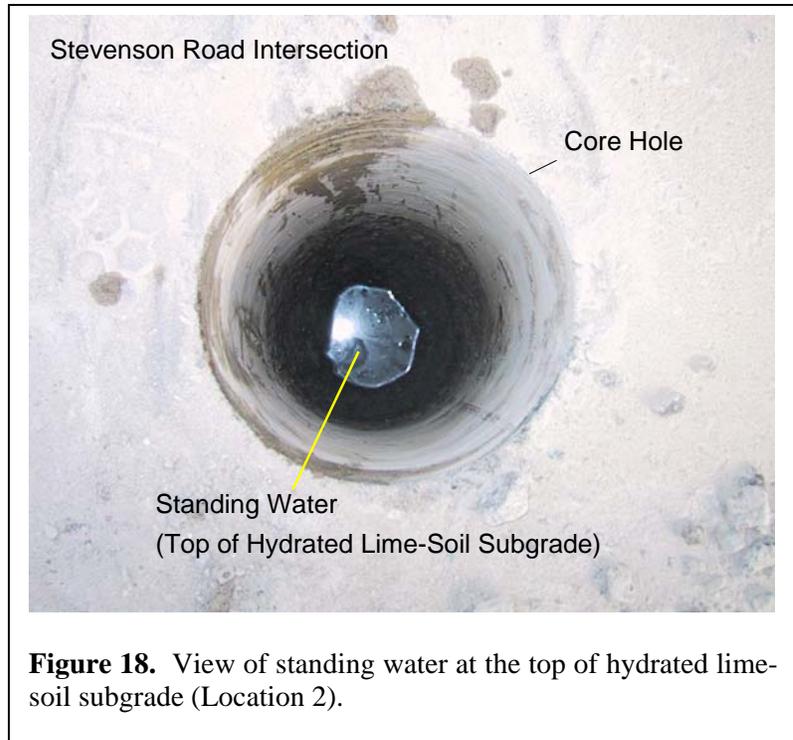
**Figure 18.** View of standing water at the top of hydrated lime-soil subgrade (Location 2).

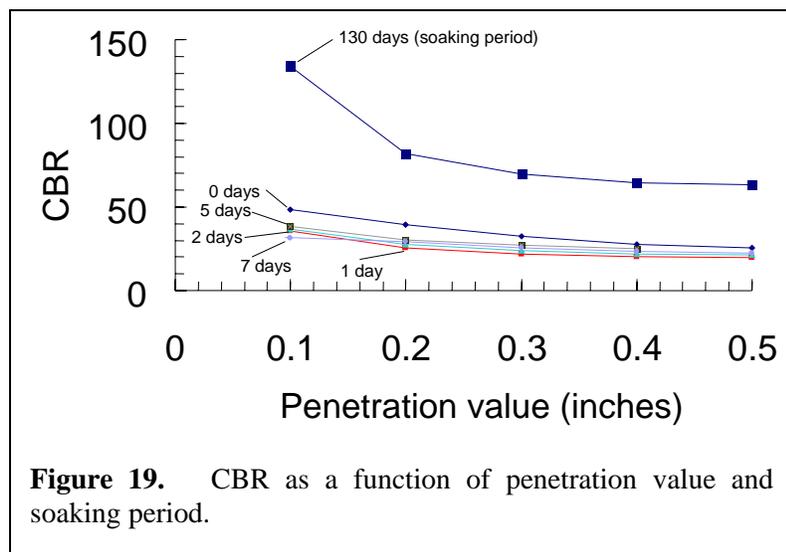
**Figure 19.** CBR as a function of penetration value and soaking period.

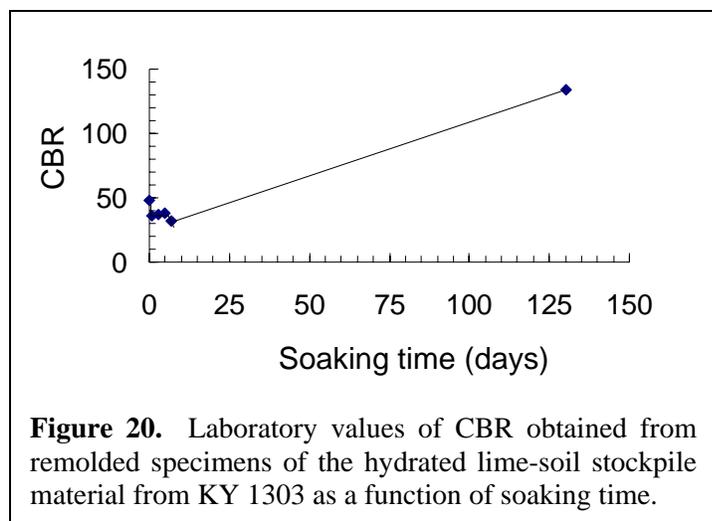
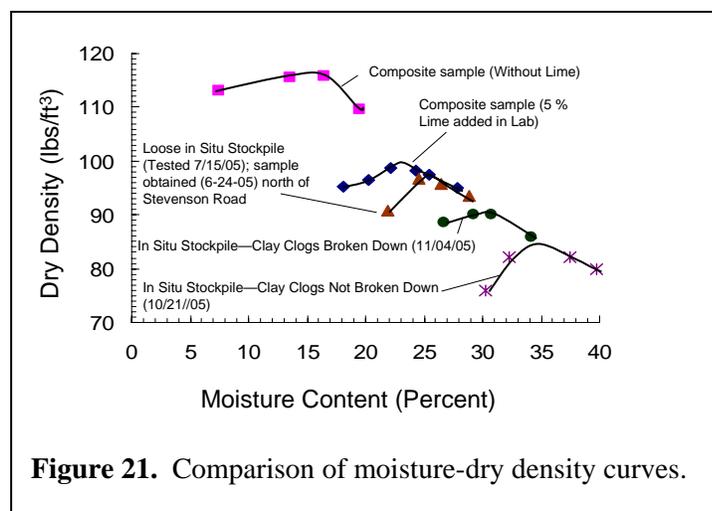
Samples were obtained from the stockpile at the time of construction. The samples were sealed in plastic bags until tested. Moisture-dry density relationships of the untreated subgrade soil and subgrade soil mixed with 5 percent of hydrated lime in the laboratory were compared previously in Figure 6. Those curves are compared in Figure 21 to moisture-dry density curves obtained

from compaction tests performed on samples obtained from the two stockpiles, which were constructed at the time of stabilization. A sample of the in situ stockpile built during construction was obtained June 24, 2005. This sample was tested October 31, 2005 (about 4 months after the stockpile was constructed) without breaking down the clay clods present in the sample. Values of maximum dry density and optimum moisture content of the in situ stockpile were 84.1 lbs/ft<sup>3</sup> and 34.7 percent, respectively. The sample was retested and the clay clods were broken down before performing the compaction test. The maximum dry density increased to 90.2 lbs/ft<sup>3</sup> and the optimum moisture content decreased to 30.0 percent, respectively. Values of maximum dry density and optimum moisture content of a sample obtained from the loose stockpile (from cuttings of the treated subgrade) north of Stevenson road were 96.7 lbs/ft<sup>3</sup> 24.9 percent. In all cases, maximum dry density and optimum moisture content of the treated samples were smaller and larger, respectively than the maximum

dry density and optimum moisture content of the untreated sample. This aspect is typical behavior of clay soils when treated with hydrated lime. The clays are usually transformed to a better material after treatment than the untreated soils.

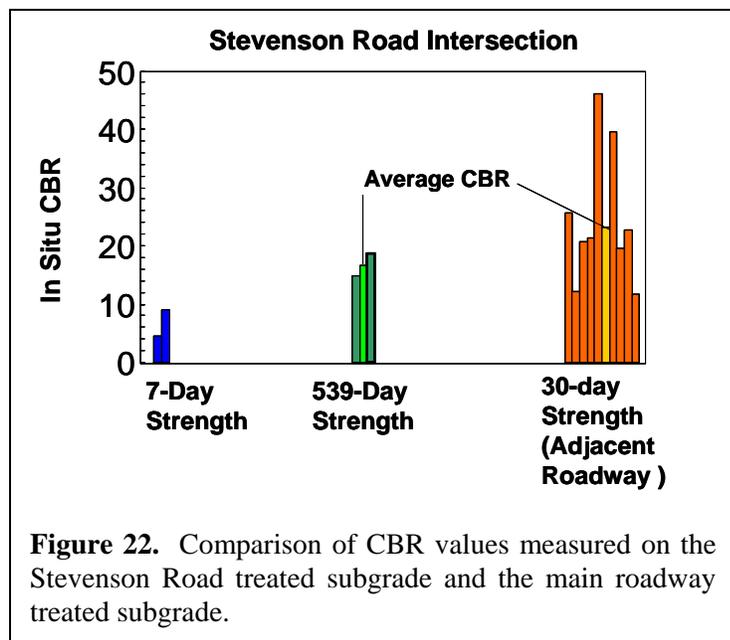
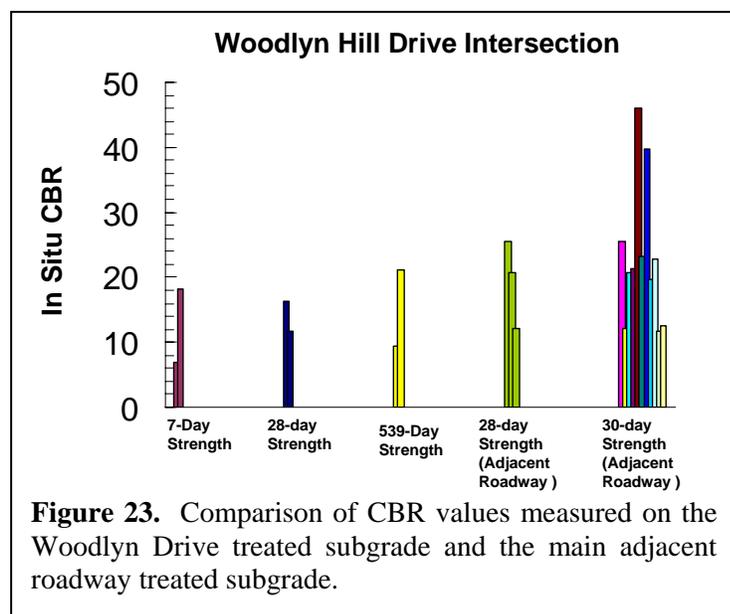
In situ CBR values measured at the stockpile hydrated lime-soil subgrade of the Stevenson Road intersection seven days and 539 days after construction are compared to CBR values measured on an adjacent hydrated lime stabilized subgrade in Figure 22. Measurements on the adjacent treated (mainline roadway) subgrade were performed about 30 days after stabilization. The average value of the 539-day CBR value (only two measurements) was 16.7 while the average CBR value of the adjacent main roadway subgrade was 23.2. The average CBR value of the stockpile-built subgrade at the Stevenson Road intersection is about 28 percent lower than the average CBR value of the main roadway. The average CBR value of the two measurements at 7 days was about 6.8 and was lower than the average of the 539-day value of 16.7. This indicates that the CBR strength of the stockpile subgrade increased with increasing time.

In situ CBR values of the hydrated lime stockpile-built subgrade measured at the Woodlyn Hill Drive 7, 28, and 539 days after construction are compared in Figure 23 to in situ CBR values of adjacent hydrated lime-treated subgrades of the main roadway measured at 28- and 30 days after construction. Average values were 12.7, 14.0, 15.3, 19.5, and 23.3, respectively. In situ CBR values of the main roadway ranged from about 11.8 to 46. Values of the stockpile-built subgrade ranged from 9.4 to 16.3 after 28 days. Although the in situ values of CBR of the stockpile-built subgrade are lower than the in situ values of the main roadway and laboratory values determined on stockpile specimens, the insitu values are very adequate, as shown in the next section, for providing substantial bearing strength for the flexible pavements at the intersections. The in situ values of the stockpile subgrade are some 7 to 16 times the laboratory CBR bearing strength (Table 1) and some 5 to 12 times the in situ CBR value (1.8) of untreated subgrades measured at several sites in this area and occurring at the 85<sup>th</sup> percentile value.

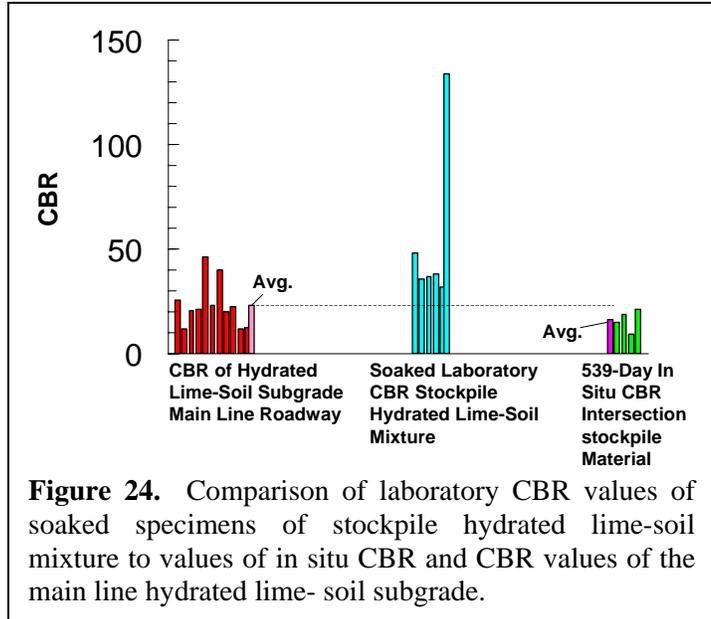
**Figure 24.** Comparison of laboratory CBR values of soaked specimens of stockpile hydrated lime-soil mixture to values of in situ CBR and CBR values of the main line hydrated lime- soil subgrade.

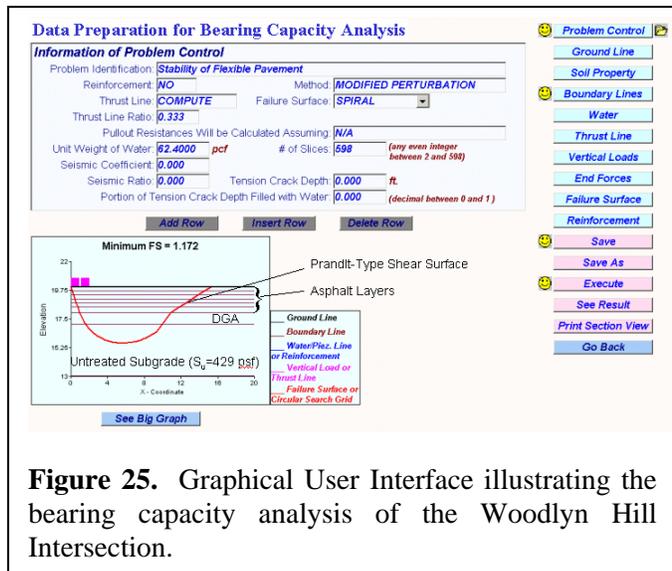
**Figure 25.** Graphical User Interface illustrating the bearing capacity analysis of the Woodlyn Hill Intersection.
